Construction Issues

Alabama Seminar
2013

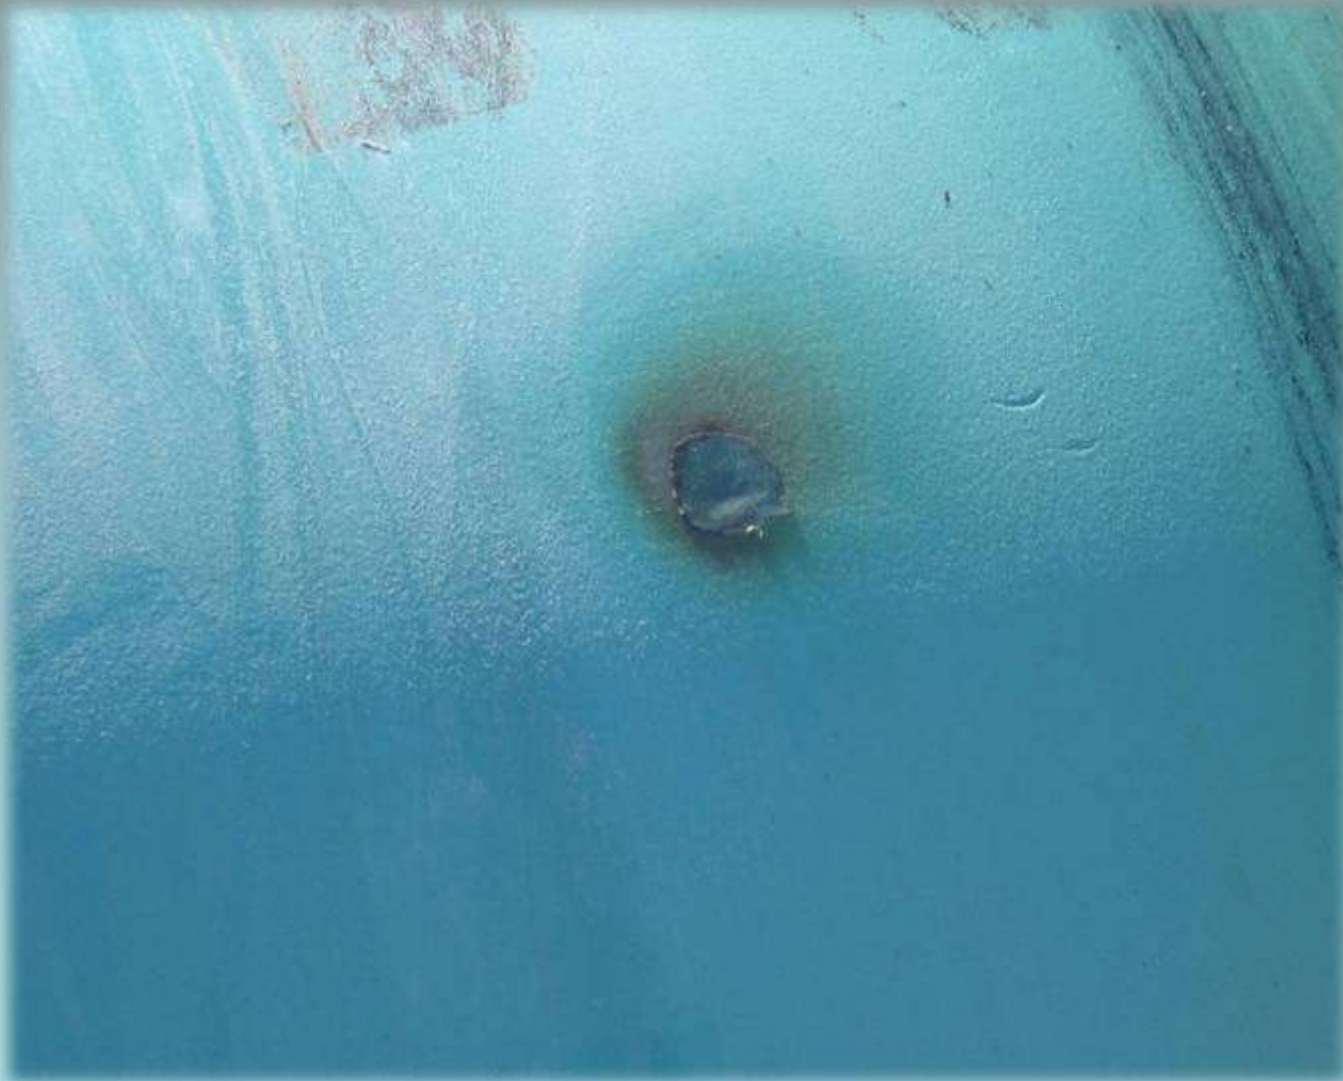
Good patch stick application - notice heated/discolored area around patch, this indicates that the pipe was heated before and during patch stick application

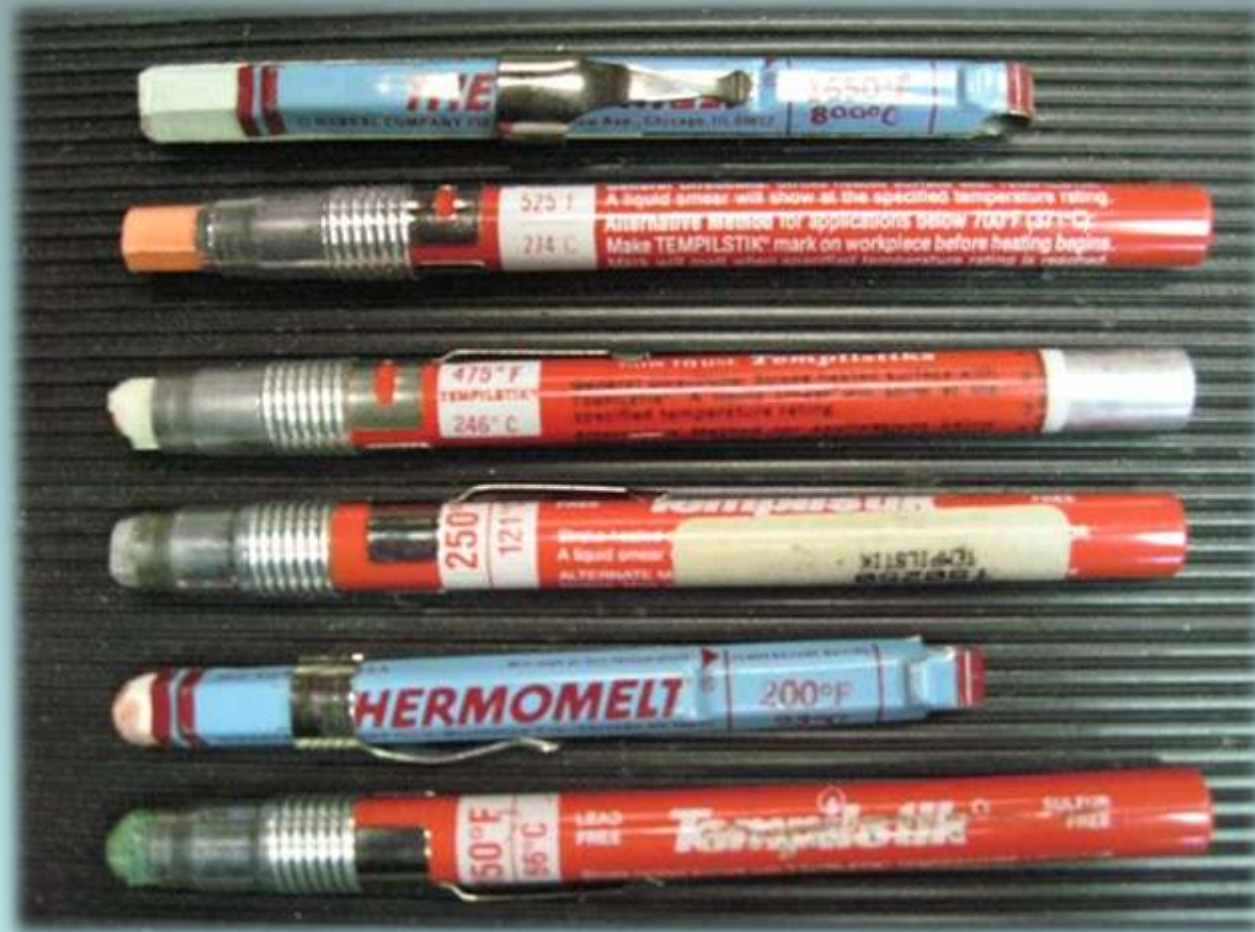
Temperature Indicating Crayons

The crayon holder specifies the melt temperature.

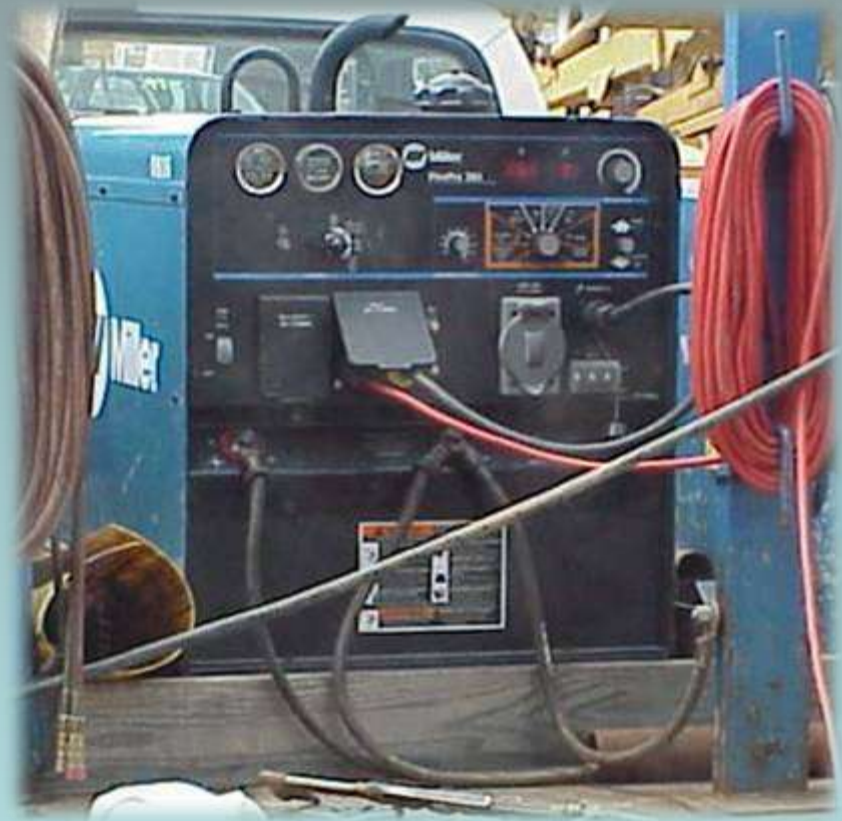
Electrical Characteristics

- Values displayed on welding machines should be within the range of the WPS.
- Machine is not calibrated but usually close.
- If outside procedure use calibrated clamp-on.

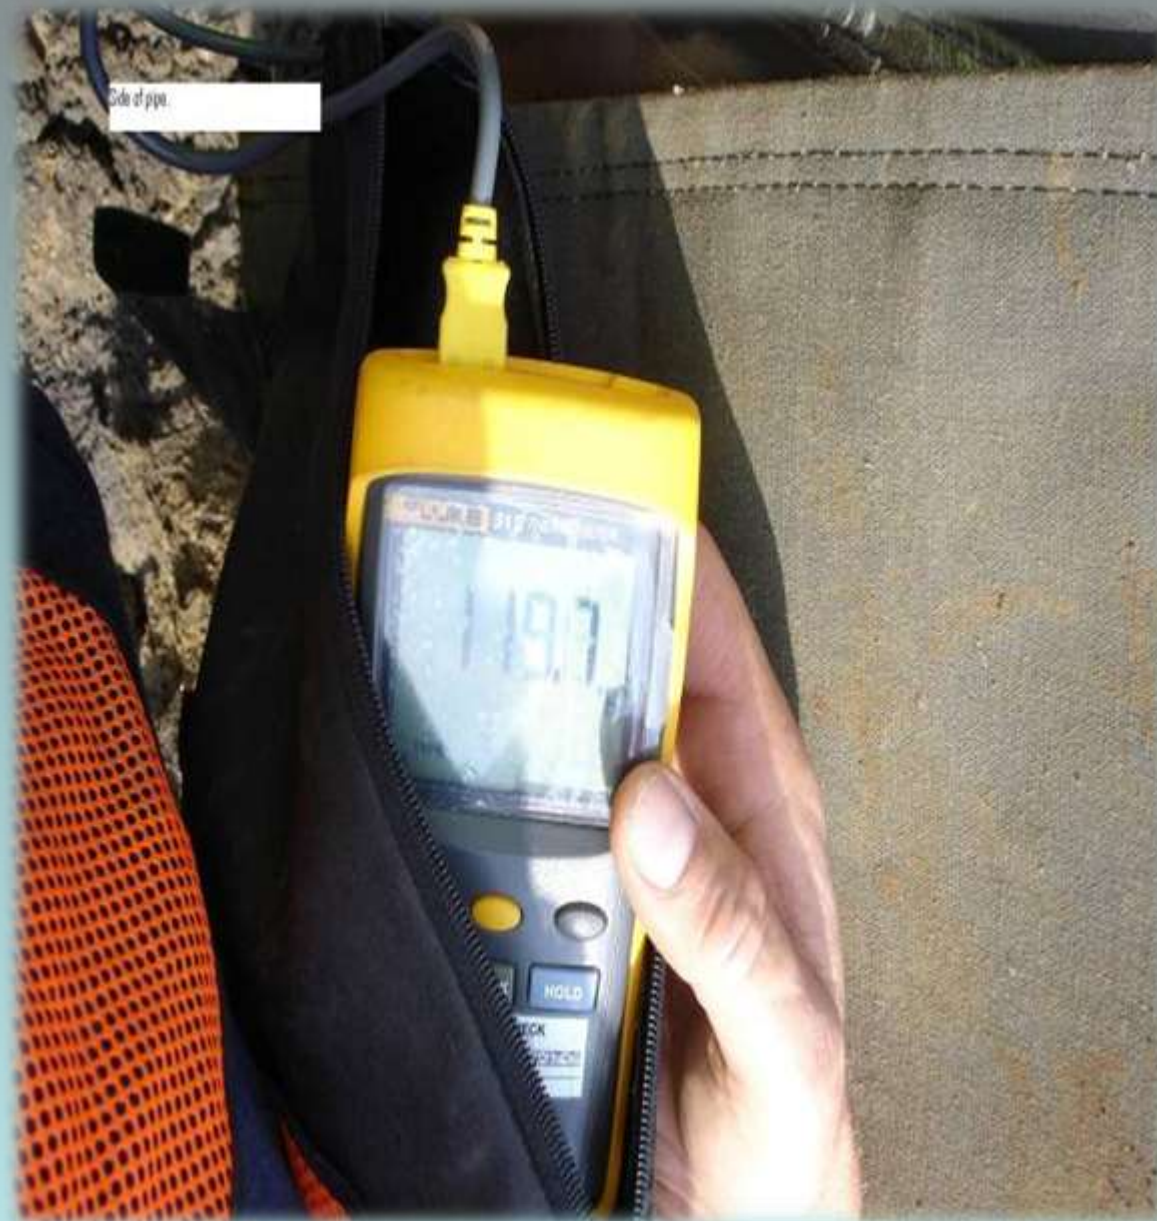
Welding
procedure
required
250°F
preheat

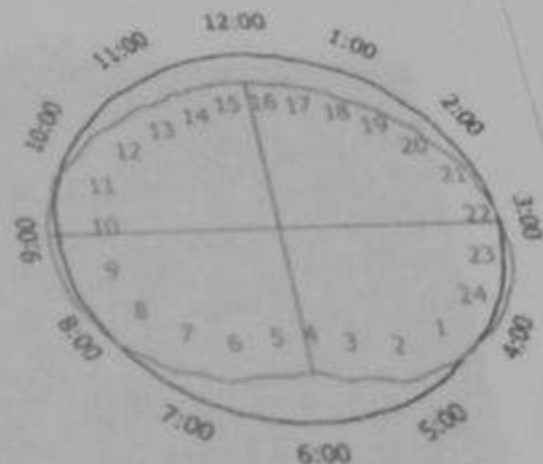
Upstream Weld # (West Weld): IPT-205
Downstream Weld # (East Weld): IPT-229

33 called to 809-34843 survey.

Well Thickness: 0.600 in
Min CSD: 37.615 in Max CSD: 41.747 in
Deformation - Ovality
Orientation: 02:50

Depth	WOD	Length
1.982 in	4.720 %	144.00 in

Affects girth weld
Field Reported

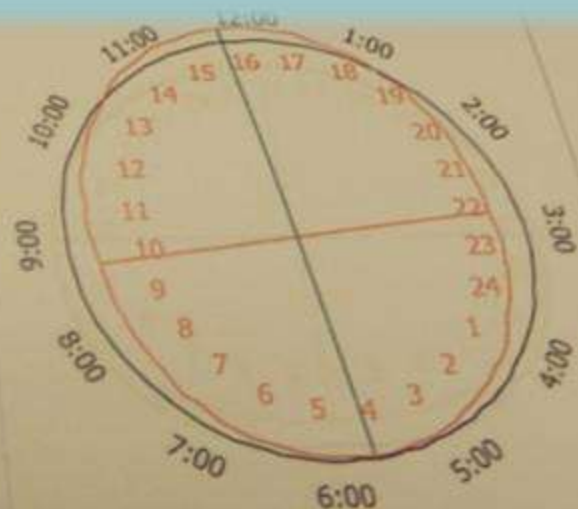
809-50882 Survey Station: 29741+65.6

This "trimmed to fit" bend appears to be under stress. Further analysis will be needed in this area to verify.

Possible stress located at this bend. A measurement for stress on this bend will not be very accurate due to the debris induced vibration seen on the upstream side of this factory

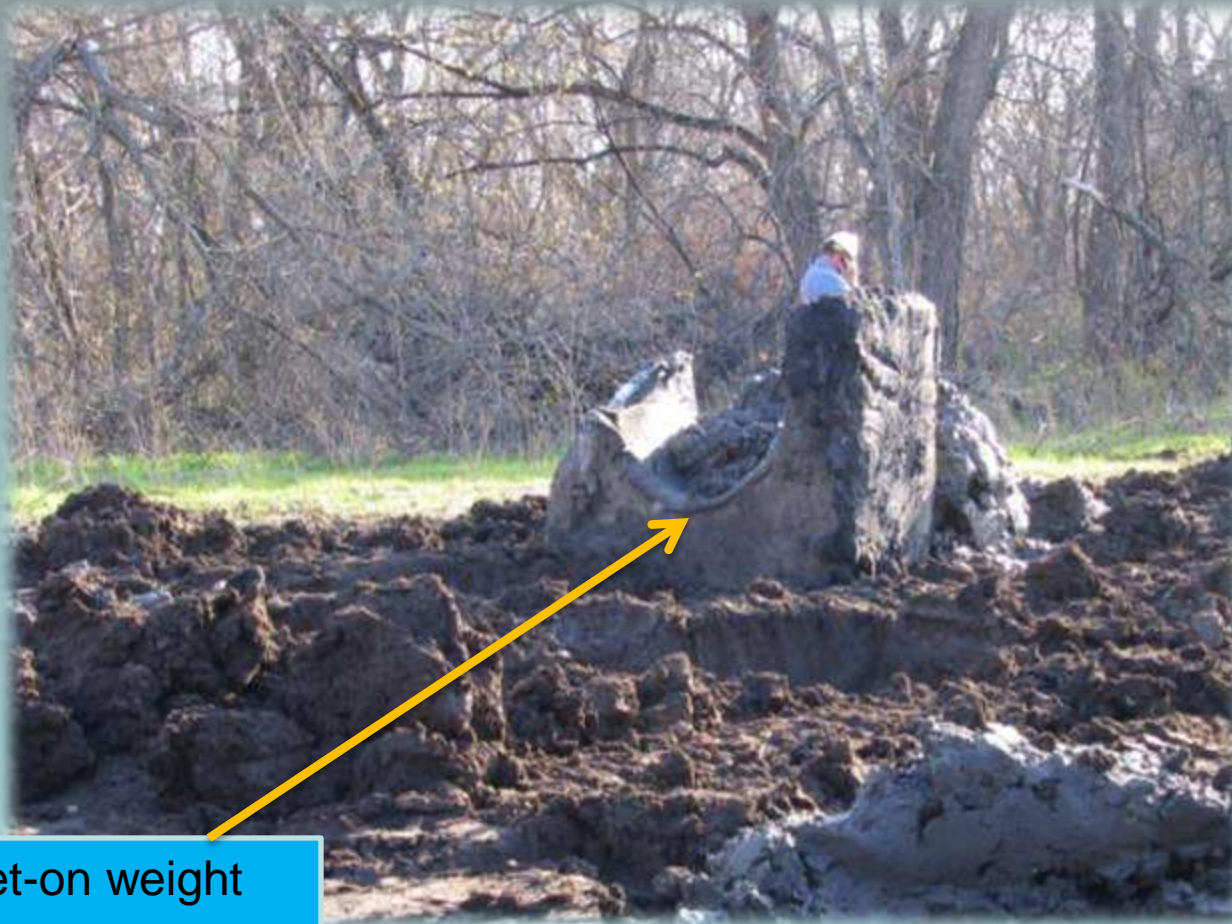
River Weight Excavation on First Phase

10,000 lb set-on weight

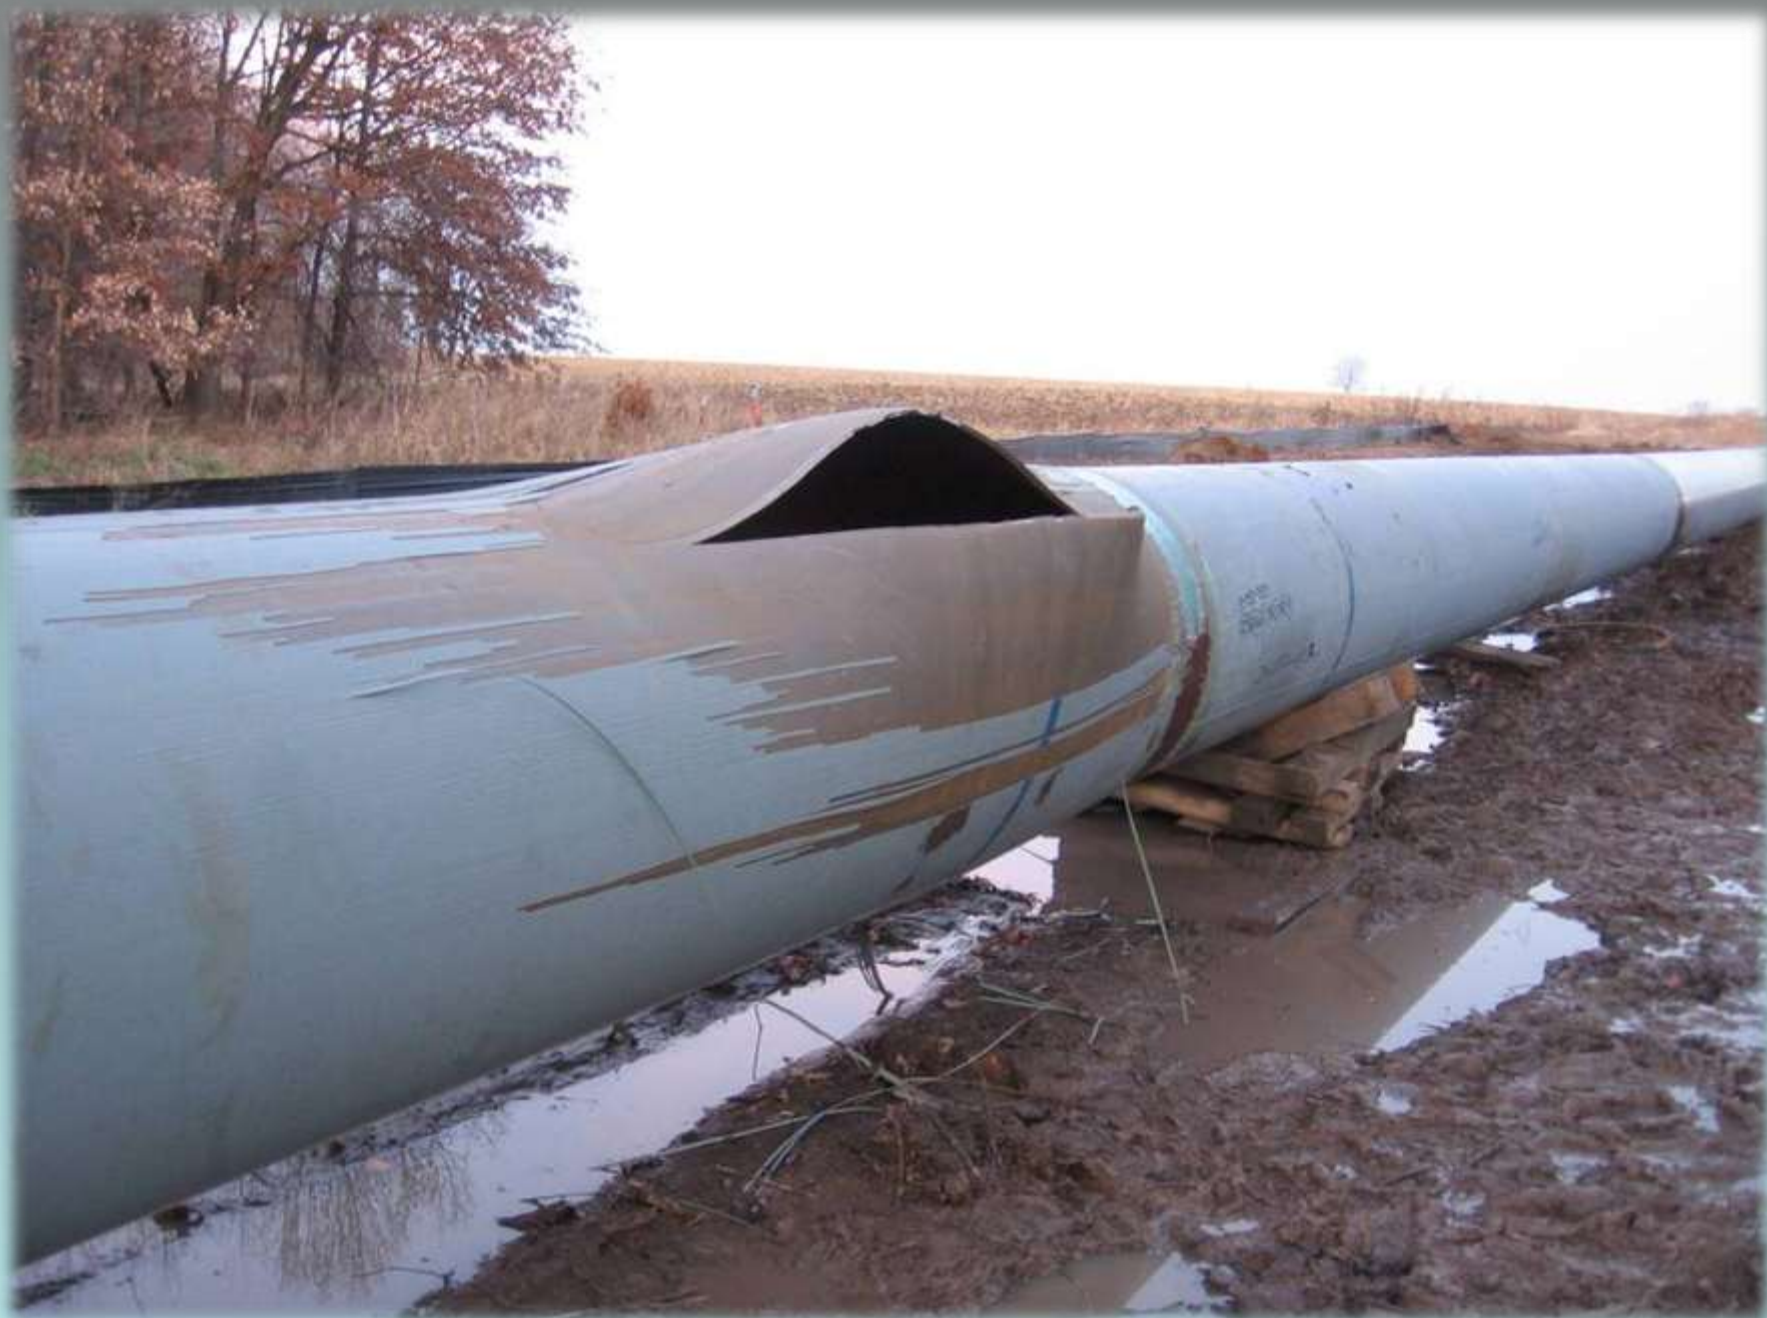
- Procedures should include provisions for cold weather testing (if not see next slide)
- Pressures should be maintained at least 8 hours for buried piping. Any pressure decline should be investigated. A second pressure test may be warranted. (See chart of failed test)

Chart shows pressure loss last 3 ½ hours

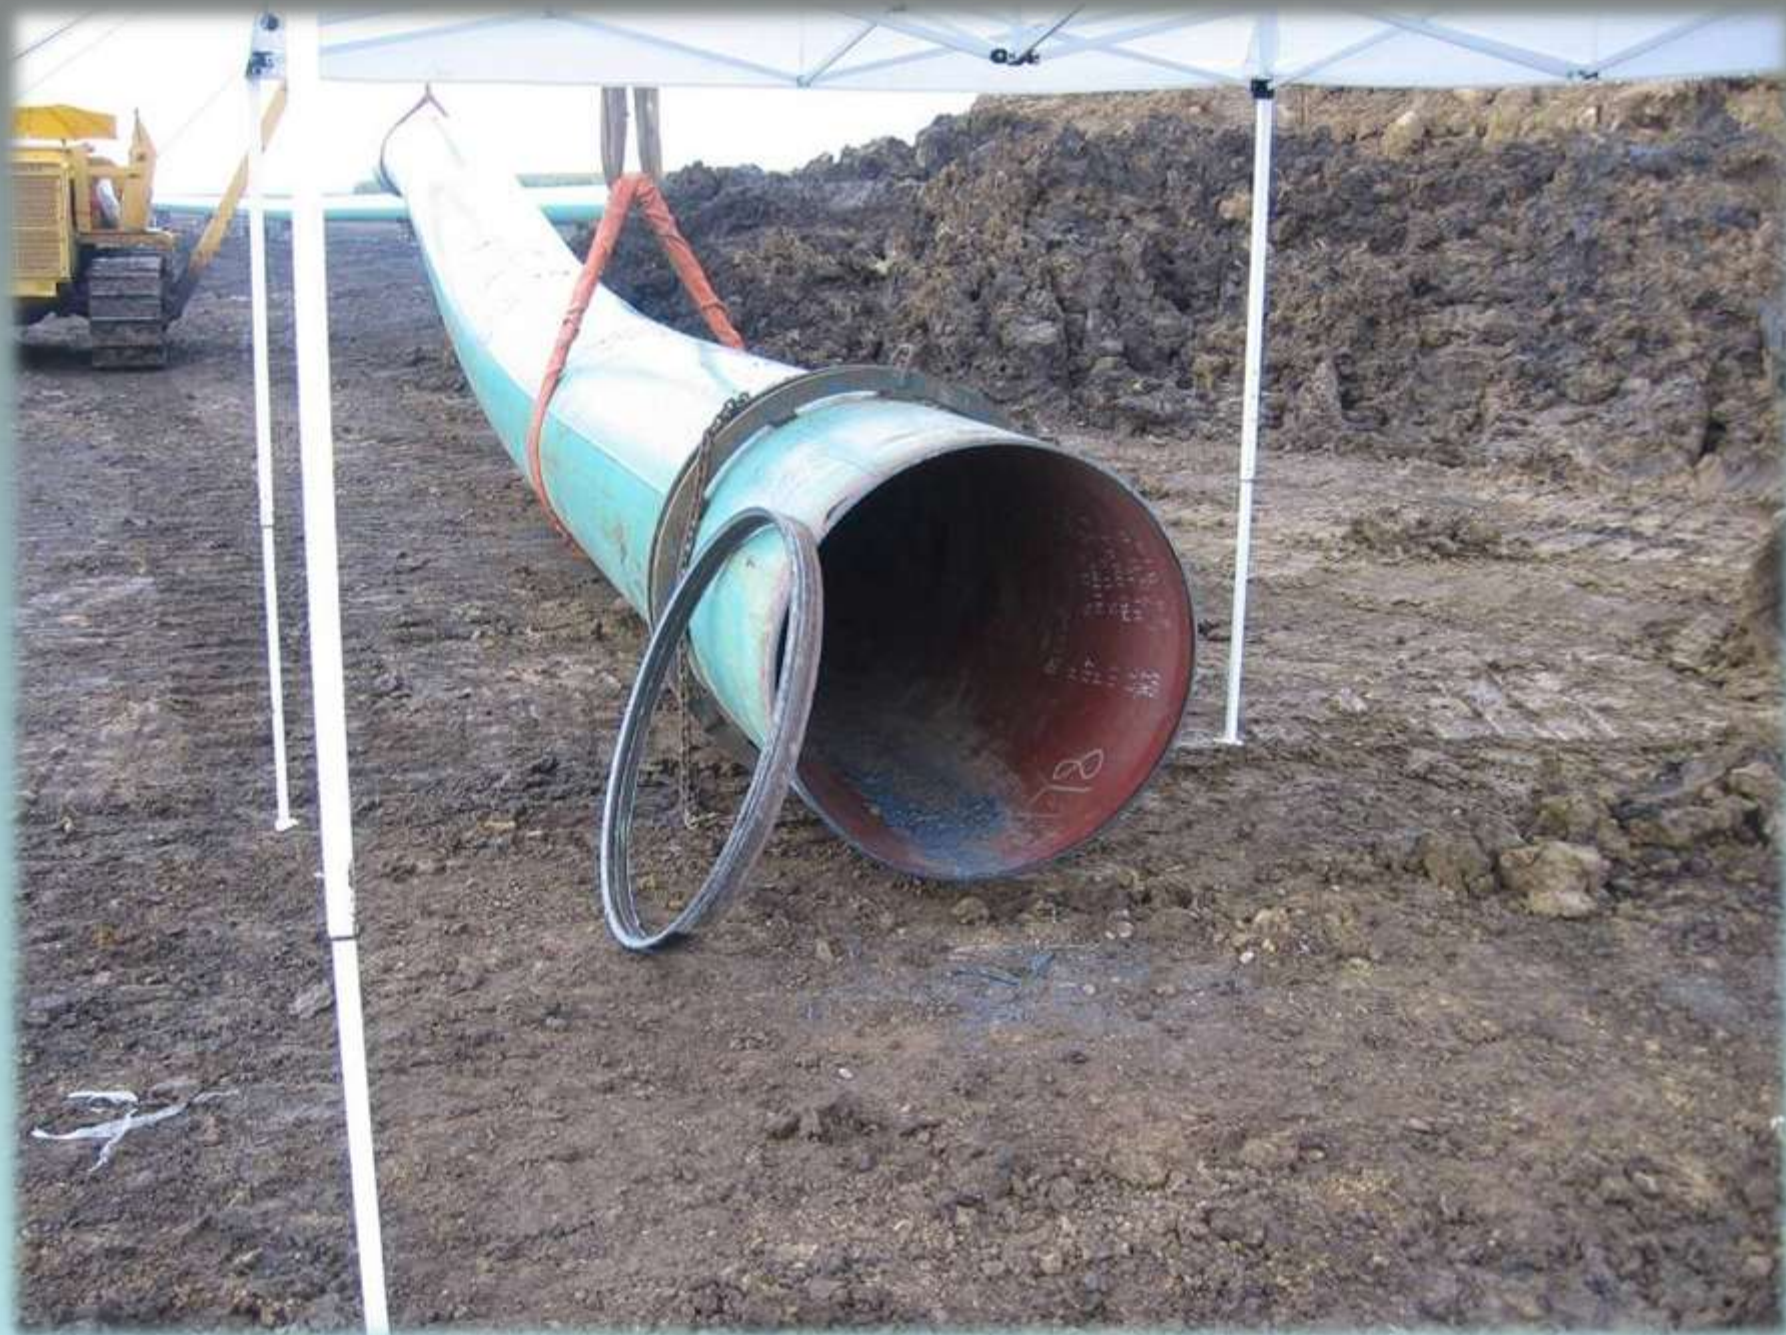
- Arc burns are not acceptable on high pressure gas pipelines and liquid pipelines.
- The following slides show that arc burns can happen during internal back welding.

The external weld was completed in the trench box. Then the welder crawled inside and completed the back weld. This was a transition weld between 0.740 and 0.486 wall thickness pipe. The welder struck the arc multiple times inside the pipe and missed the bevel multiple times.
